Devcon® Titanium Putty & Devcon® Brushable Ceramic Coatings Repair & Protect Pressure Vessel from Corrosion

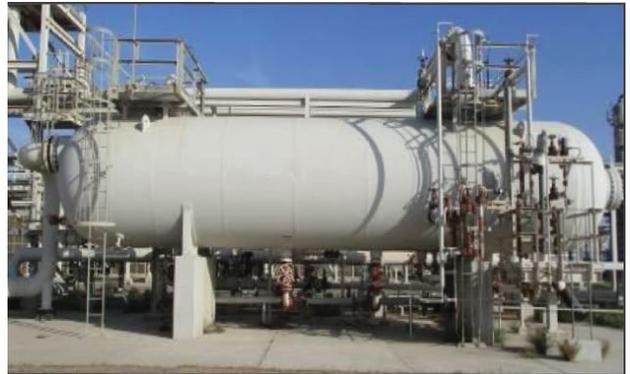
Petrochemical pressure vessel

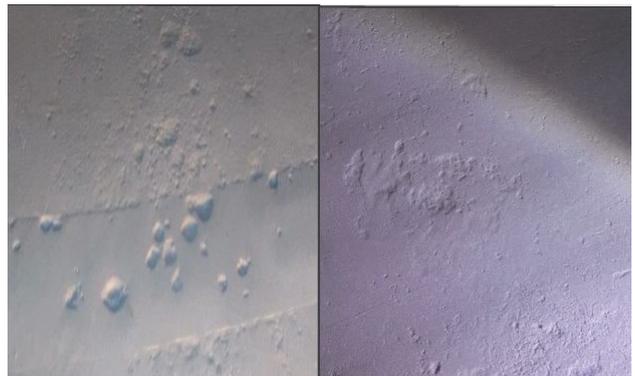
A petrochemical facility based in the Gulf region had a corroded pressure vessel that needed to be urgently repaired. With signs of cavitation evident within the equipment and increasing risk of leaks, the customer was seeking a safe, quick and economical repair solution.

Cavitation and corrosion inside pressure vessel

- Devcon Titanium Putty was then spread to fill up all the anomalies, then the application thickness was unified over all pitting locations. After curing, the first coat of Devcon Brushable Ceramic was applied using a hand brush.

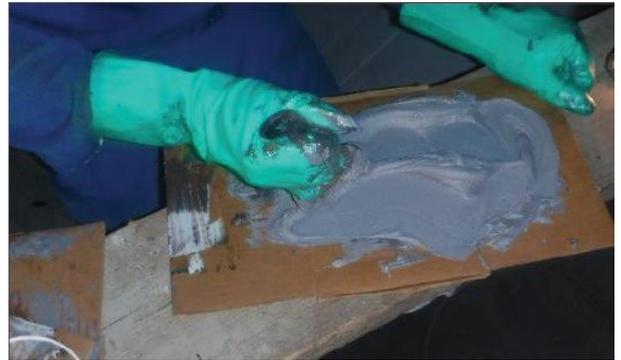
Devcon Titanium Putty resin & hardener mixed on board for filling & fairing defects

- Devcon Titanium Putty part A and part B were thoroughly blended on the mixing board using a 3" mixing spatula. This was used for filling and fairing the anomalies / defects in the vessel.

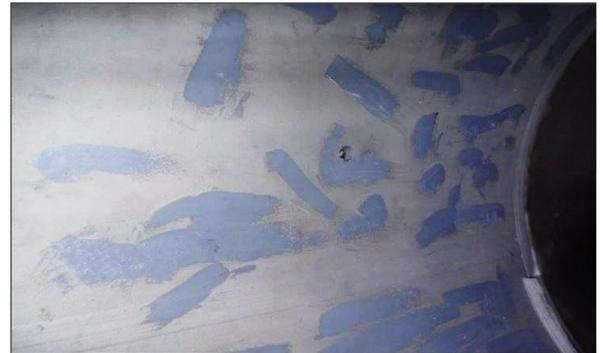
Devcon Titanium Putty applied over damaged areas inside pressure vessel

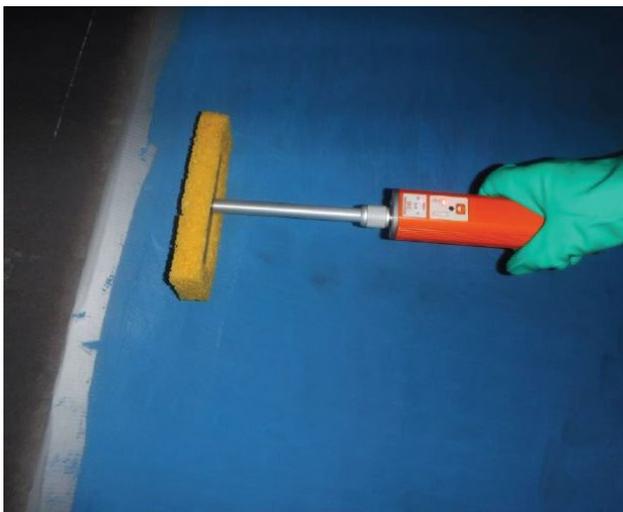
Holiday detector evaluating the coating of Devcon Brushable Ceramic Blue

- The Wet Film Thickness of Devcon Brushable Ceramic was confirmed to be within the acceptable range (350 to 500 microns). An additional coat was applied using the same methodology. No spark was shown by the Holiday detector upon completion.

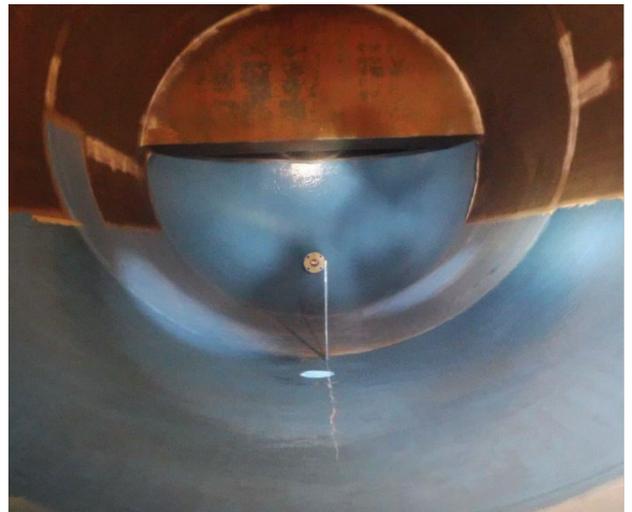
Restored vessel interior after application of Devcon Titanium Putty & Devcon Brushable Ceramic Blue

Devcon Titanium Putty and Devcon Brushable Ceramic Blue coatings provide long-term, corrosion protection that restored the pressure vessel to its original and intended operating condition.
